Offshore Wind Turbine Maintenance Specialist

Project Information - Monopile Preservation

Scroby Sands Wind Farm is an Offshore Wind Farm located 1.5km off the Norfolk coast. The wind farm consists of 30 Wind Turbine Generators each rated at 2MW, mounted on monopile foundations. The Wind Farm has been operational since 2004 and is one of the UK's first commercial Wind Farms located in Great Yarmouth, which is owned and managed by E.ON from a local facility.

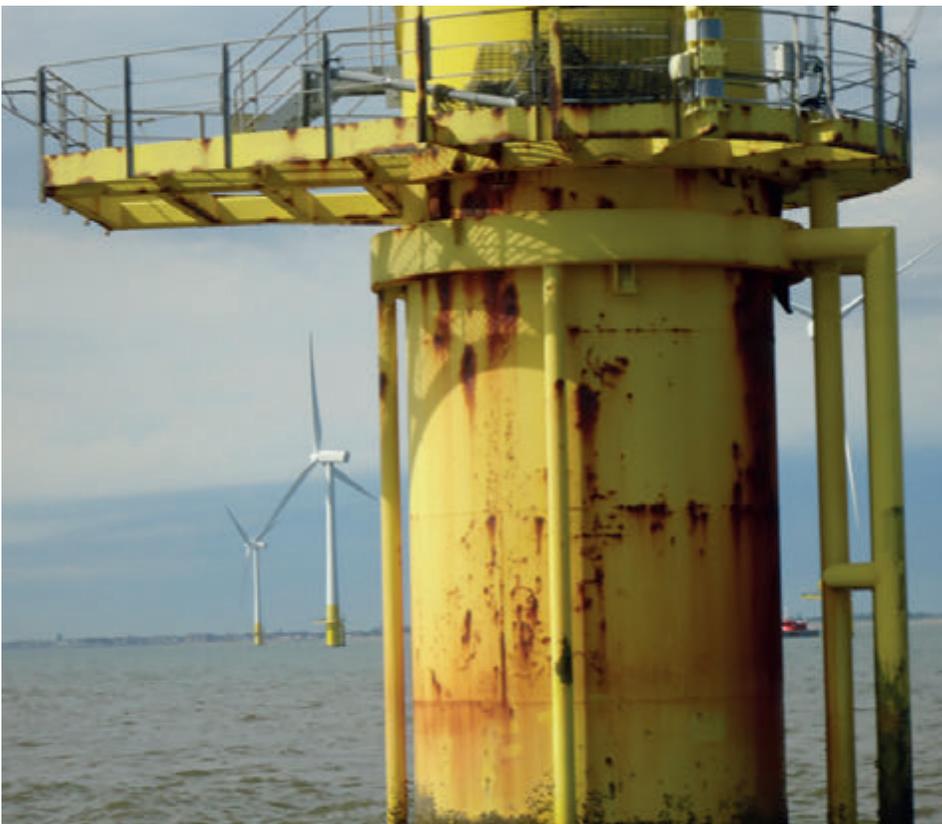
Existing condition of Monopile steel, detailing corrosion to structural beams below gratings and main body of structure

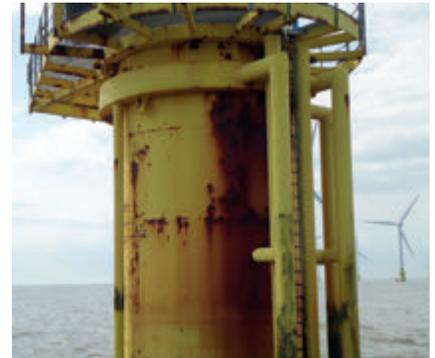
Picture detailing severe corrosion to main steel sections below gratings

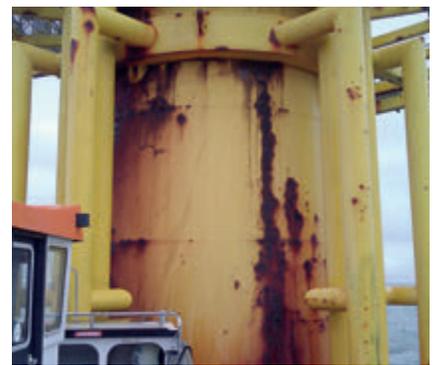
Corrosion of Monopile structure

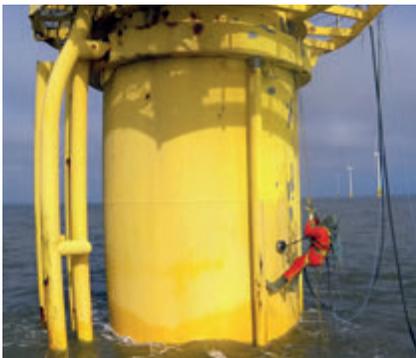
Blasting structure by means of rope access with unique magnet system

Rope access blasting and spraying has been performed with ABFAD Ltd unique patented permanent magnet clamps in conjunction with rope access equipment. The magnetic clamps assist rope access blaster/sprayers to hold their position whilst suspended from ropes, reducing standard work norms. This technique ensures blaster/sprayers can perform their work to the highest quality due to the magnets holding them securely in position with no lost time to tie-in on each and every drop on Monopile structure.

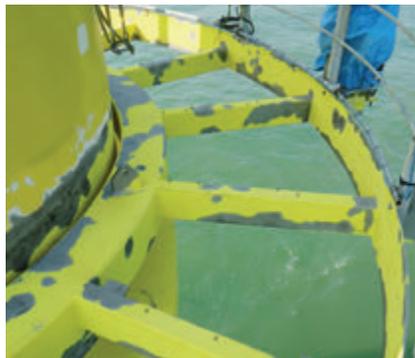
Picture detailing all corrosion removed to blast standard SA2.5 with sound paint profiled to take new spray coating

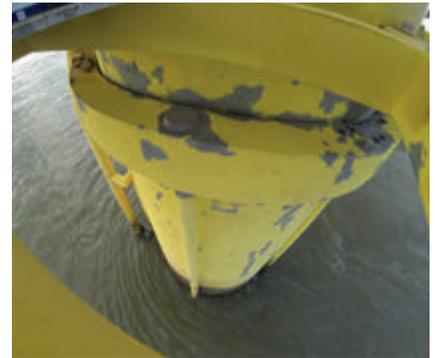
Work in progress on Monopile with sections of corrosion removed and existing coating profiled and feathered back in preparation for spray coating

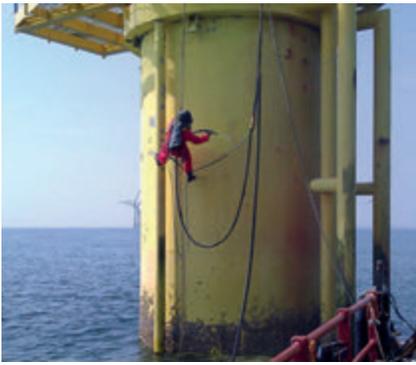
Rope access blasting to SA2.5 standard with sound paint profiled to take new spray coating

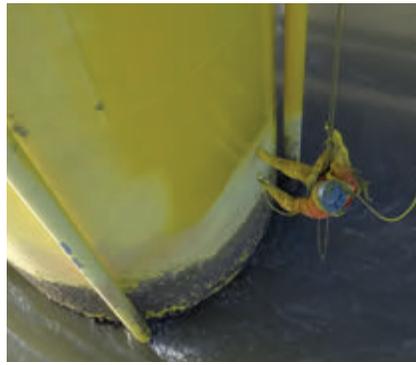
New protective coating being applied to the main structure

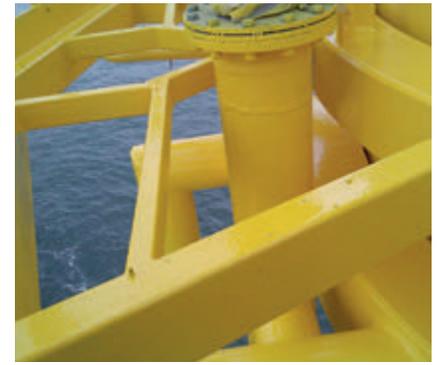
Close up of new protective coating, applied by airless spray unit, applied to required thickness to main structural steel below gratings

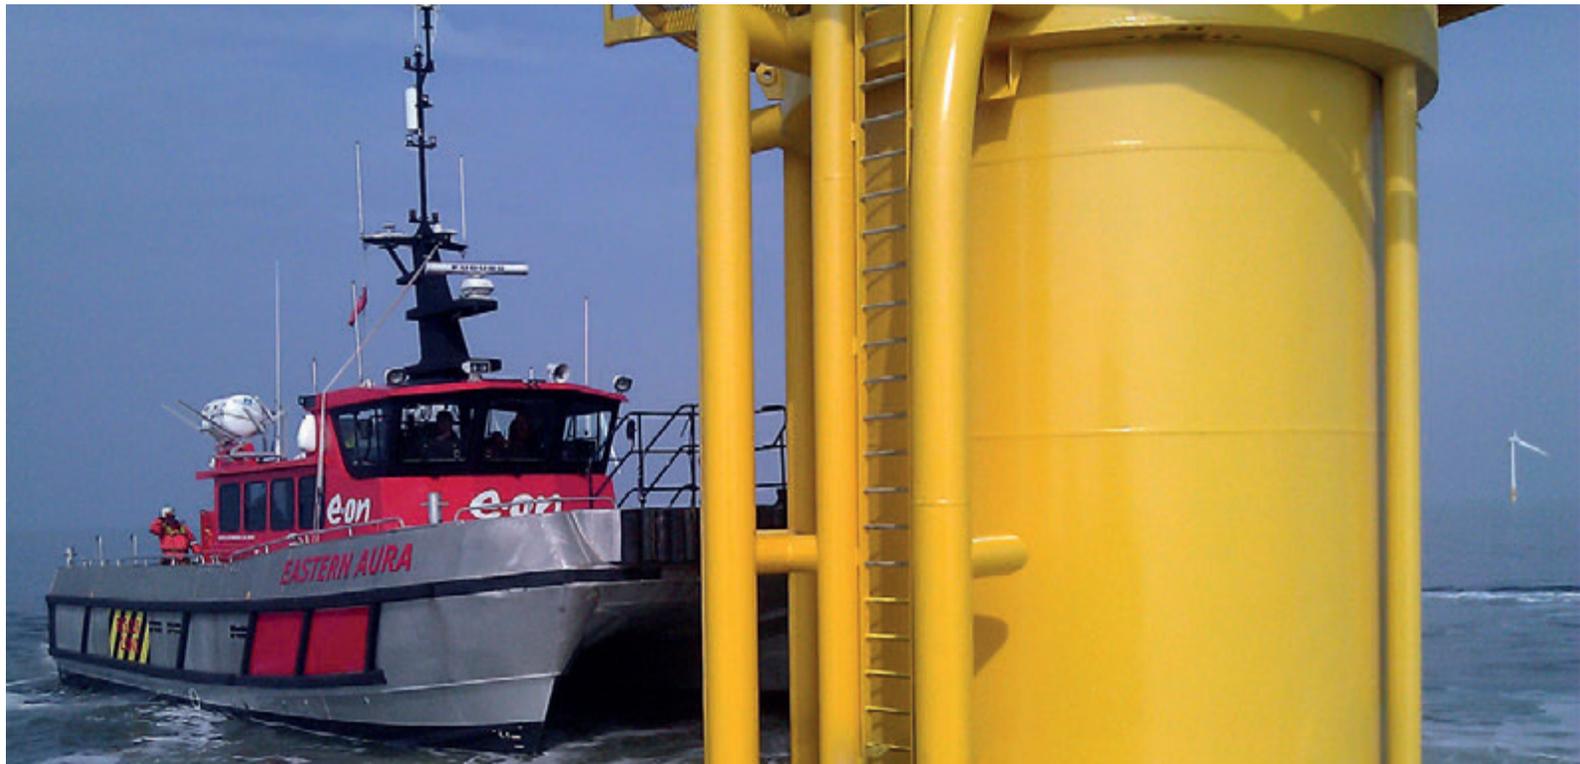
Picture detailing completed Monopile structure which has been fully blasted and protected by nominated coating from walkway grating beams to sea level, including all pipework

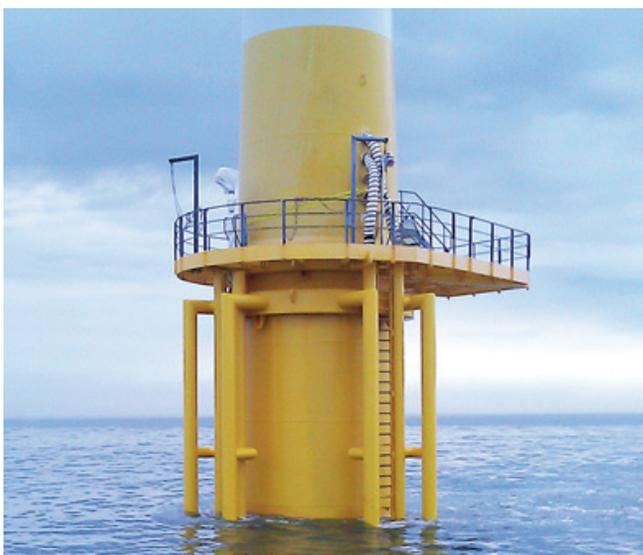
Completed Monopile structure after protective coating applied

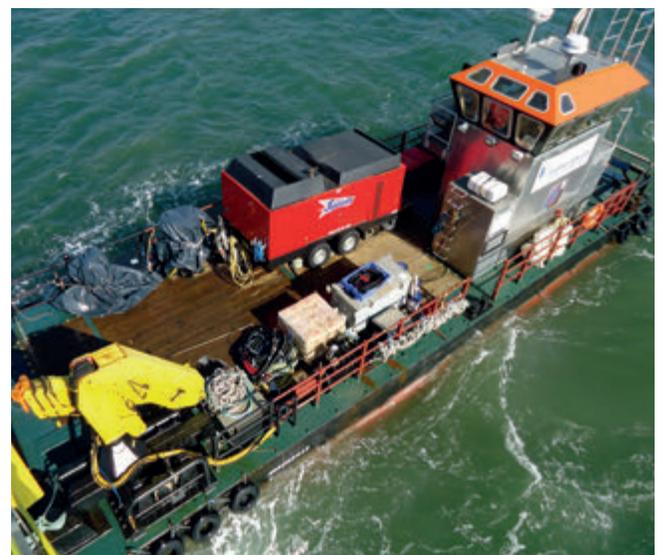
Picture showing the equipment used, which was transported to the turbine on a support boat
