Offshore Wind Turbine Maintenance Specialist

Project Information - Met Mast Restoration

Met mast off the coast of Great Yarmouth, Scroby Sands. Due to corrosion and mechanical damage to access ladders, a tender was awarded to Abfad Limited by E.ON Climate & Renewables UK Ltd.

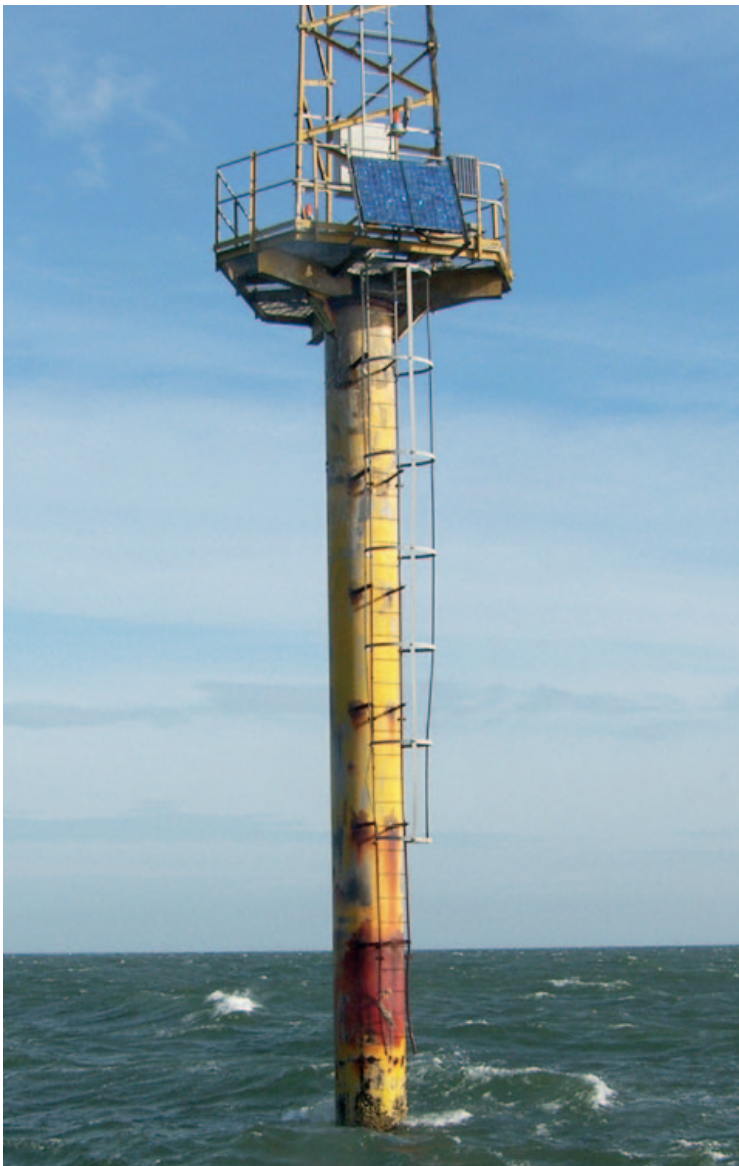
Corroded and damaged Met Mast at Scroby Sands, Great Yarmouth.

Project was to fabricate new ladder sections and eight clamps, blast clean the structure to SA2.5 and apply a protective coating, remove existing damaged ladder sections, install new clamps, tighten using Hydratight hydraulic equipment, then install new ladders to structure.

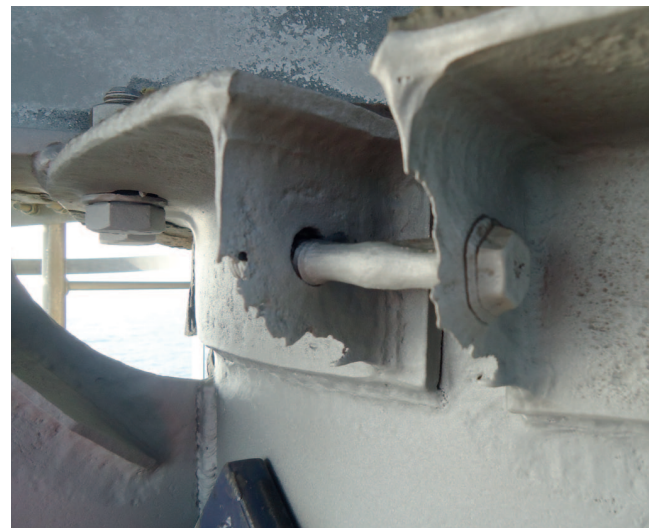
Detail of extent of corrosion to steelwork below main walkway section after blasting works completed.

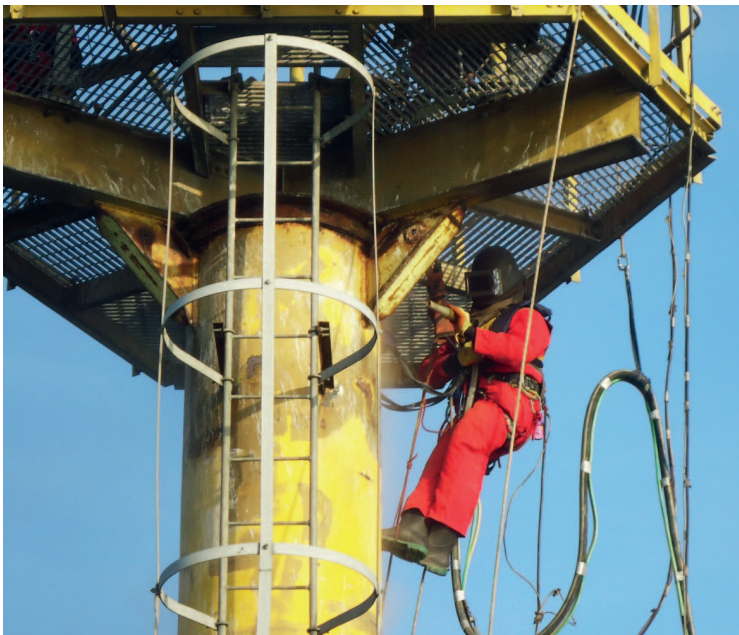
Blasting corrosion on underside of walkway and top section of Met Mast structure using rope access techniques.

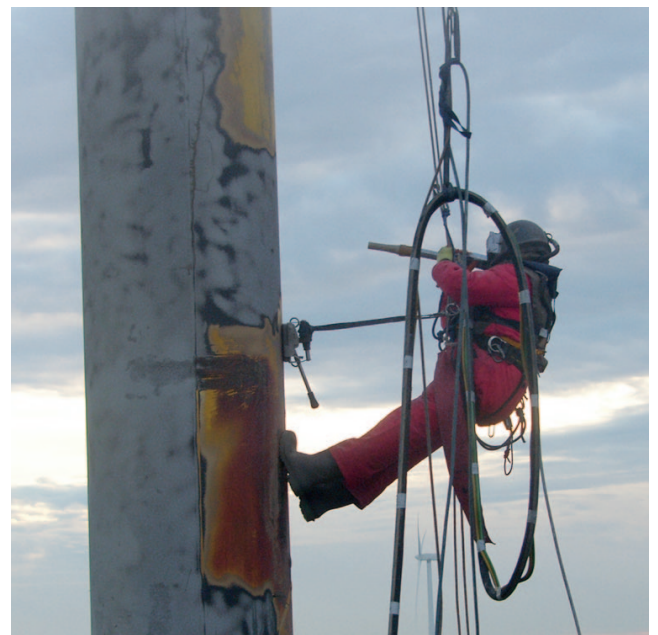
Blast operations to Met Mast stem using rope access techniques and Abfad's patented magnet system used to hold the operative in position during blasting.

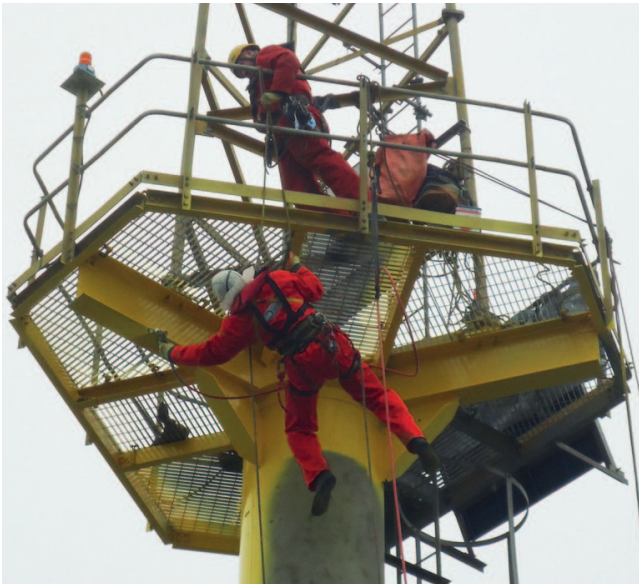
Spray coating steelwork after blasting completed.

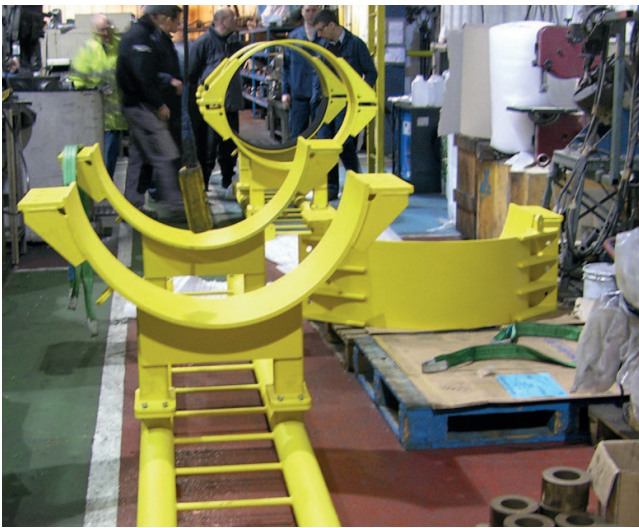
New ladder sections and clamps were fabricated, to be installed once blasting and coating work completed.

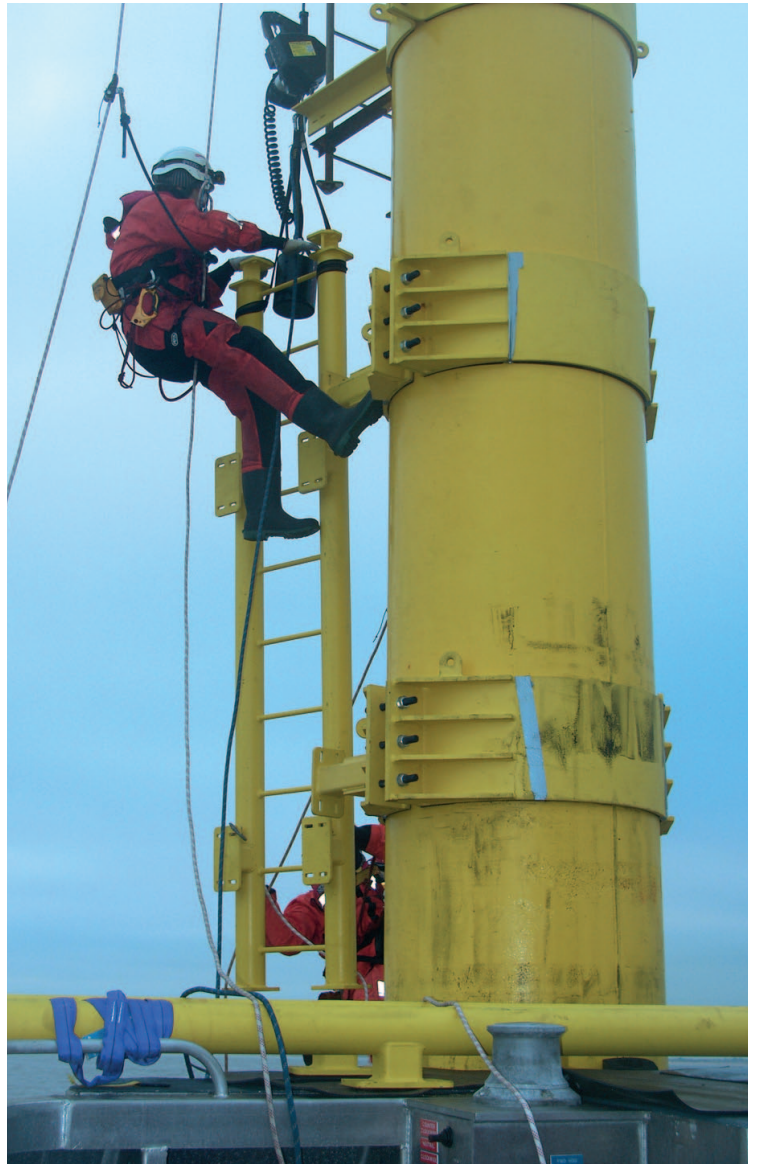
Installation of new ladder section, Abfad electric battery winch used to move and hold ladder section in place during installation.

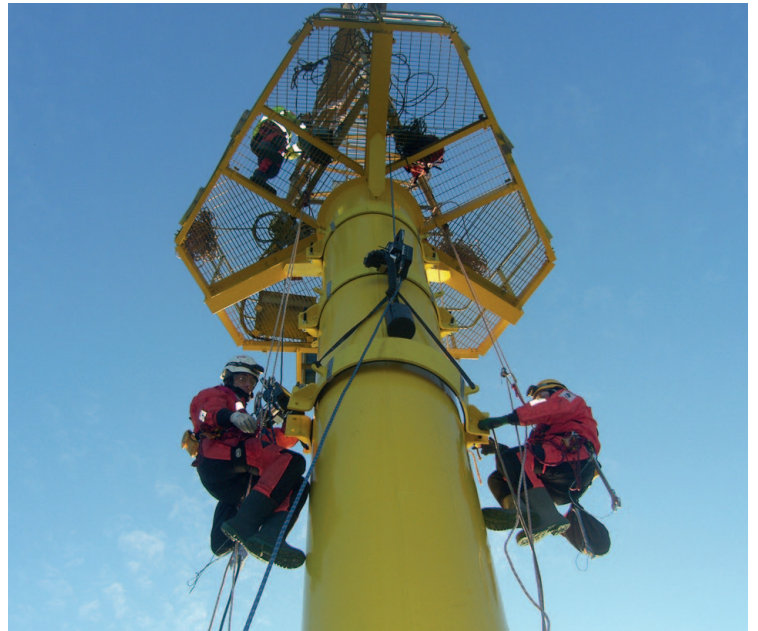
Newly fabricated Clamp sections being installed by Abfad personnel using rope access techniques.

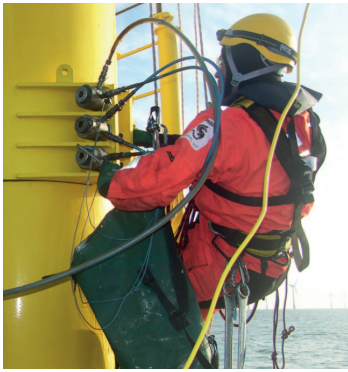
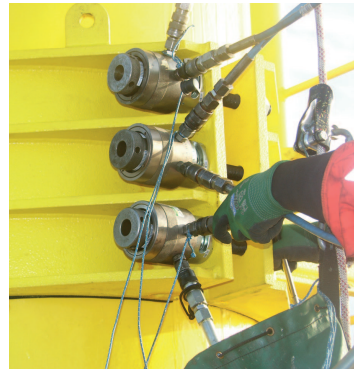
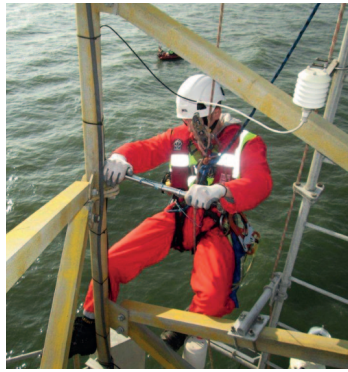
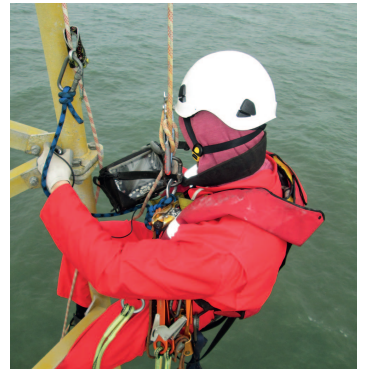
Trained Abfad personnel tightening clamps using Hydratight hydraulic equipment.

Once all work was completed, NDT inspections on the Mast were carried out during another visit. This included the tightening of all bolts on the structure.

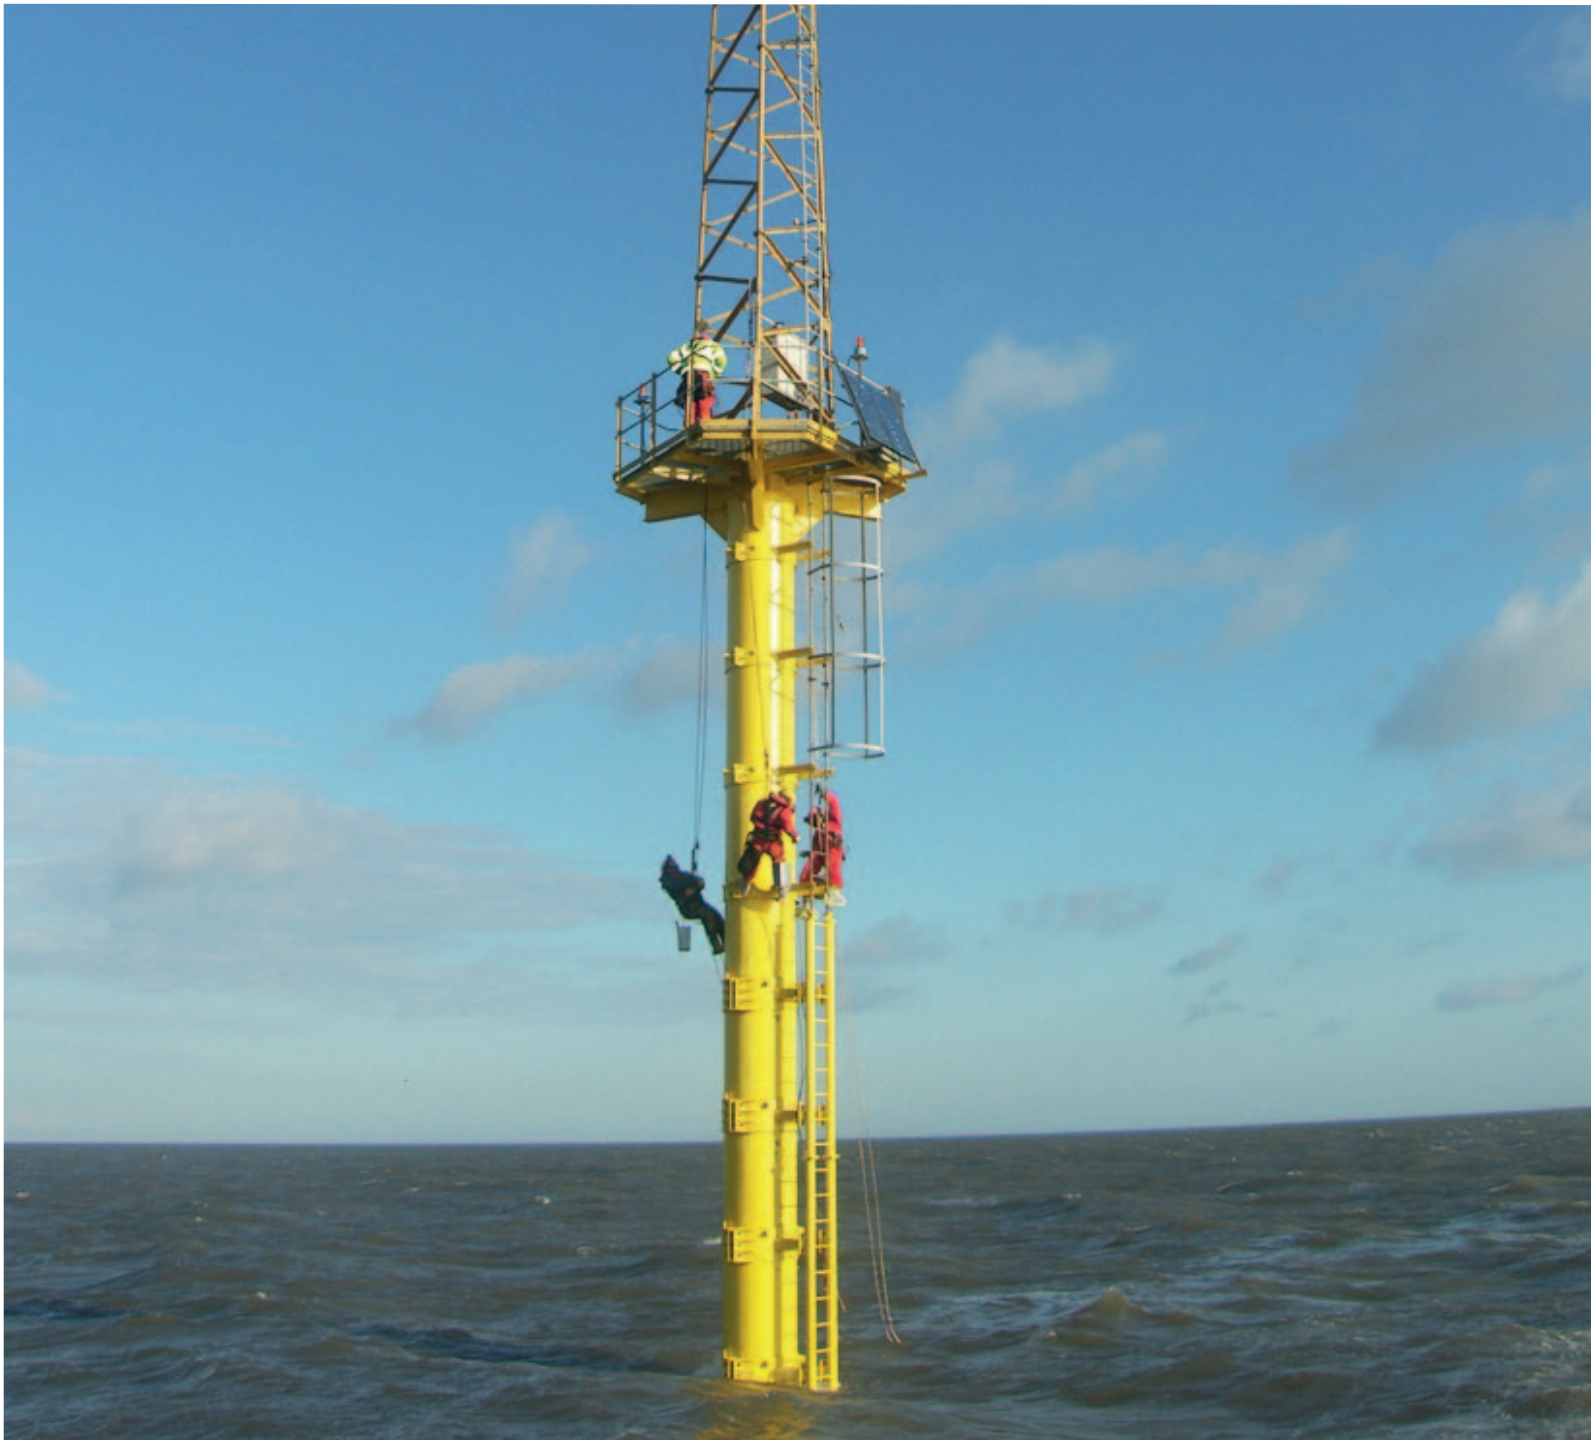
Abfad personnel performing finishing touches and final checks on Met Mast at Scroby Sands, Great Yarmouth.
