CASE STUDY

Durham forecourt site
Fibreglass fuel storage tank
Repair and coating

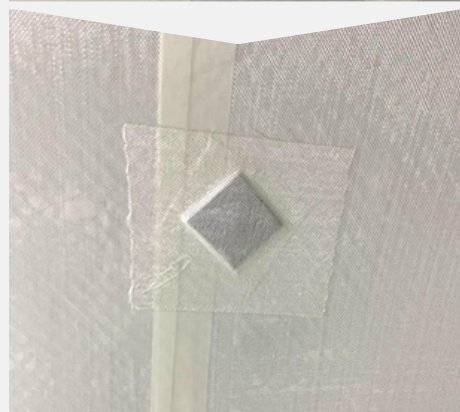
ANCHOR PAD INSTALLATION

Anchor pads add strength and structural integrity to repair materials.

Fibreglass construction fuel storage tank leaking in several places, unable to hold fuel anymore.

1. Repaired the leaking tank with fibreglass sheeting and resin.
2. Applied a double-skin system with class 1 vacuum monitoring enabling the operator to have 24/7 monitoring of the tank.
3. Installed anchor pads onto the deck head and around the dome ends of the tank for added strength to the newly installed materials.
4. Over-coated the whole tank with a fuel-resistant coating to prevent further leaks and improve durability.

The storage tank was fully repaired and all leaking areas were reinforced with fibreglass sheeting and anchor pads to ensure future structural integrity.
