An underground fuel storage tank at an RAF site in the UK site was designated to be internally renovated and have a new double-skin liner installed as the previous one had failed. The 10,000-litre capacity tank stores aviation fuel and is a carbon steel single wall construction.

FUEL VAC®
THE INNOVATIVE DOUBLE-SKIN LINING SYSTEM

A Case Study

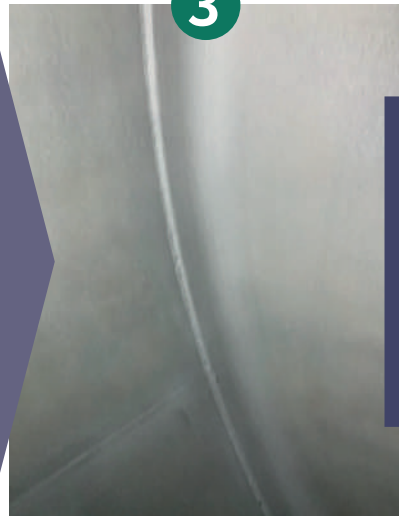
3

Shot blasting was then performed to Swedish Standard SA 2.5 to create an angular profile of ≥ 75 microns to allow for greater adhesion.

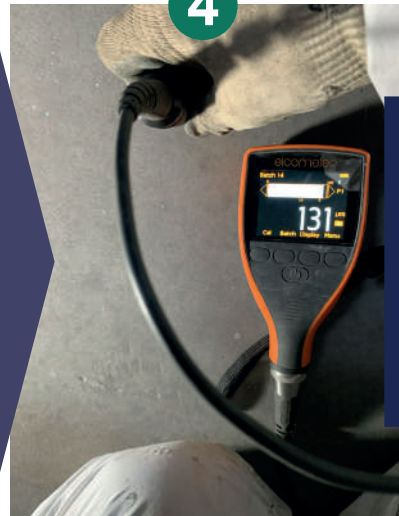
4

The blast steel profile achieved was around 131 microns, allowing for excellent adhesion of the coating.

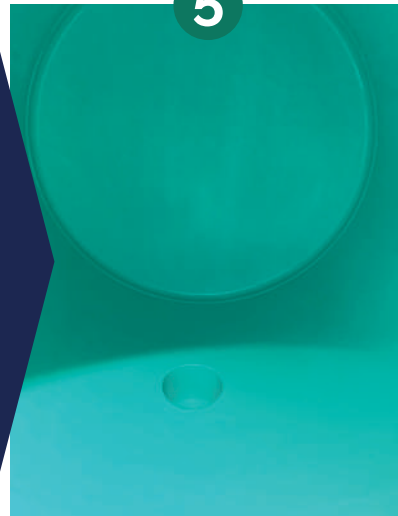
5

A solvent-free coating was applied to the tank as a first layer, in preparation for installation of the double-skin liner.

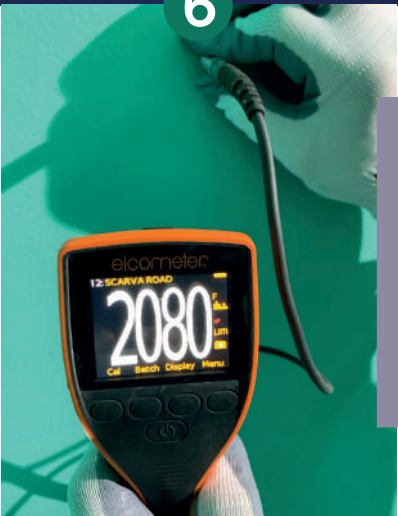
6

This first coating was applied to 2000 microns nominal thickness to provide total encapsulation of the tank steel as the first protective barrier.

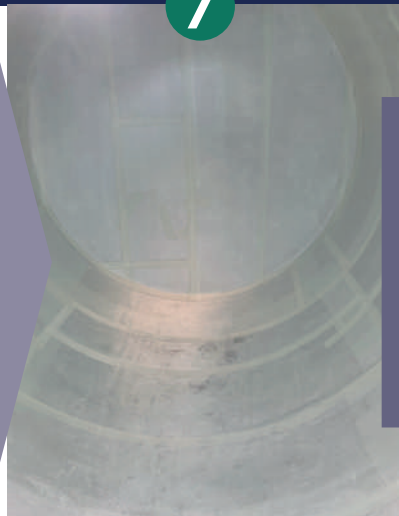
7

All double-skin lining materials are applied on top of the initial coating. These materials are non-hazardous and create an interstice around the tank.

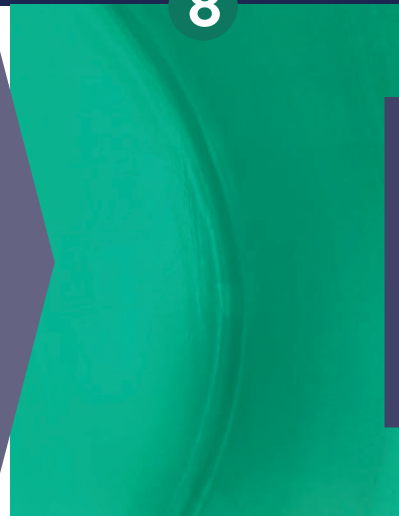
8

Final solvent-free coating on to the lining materials, applied to 2mm nominal thickness as the finish coat. This completes the work inside of the storage tank.

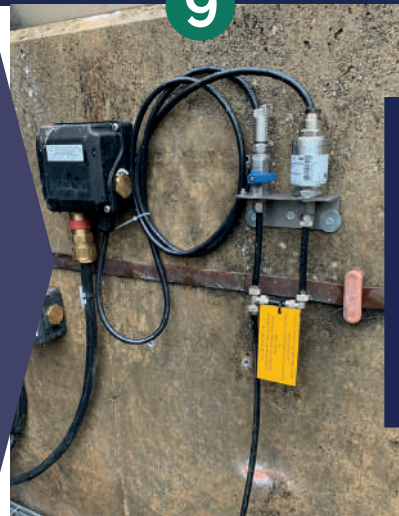
9

Vacuum transducer valve located in the tank chamber, this is connected to the interstice of the double-skin liner for the vacuum monitoring.

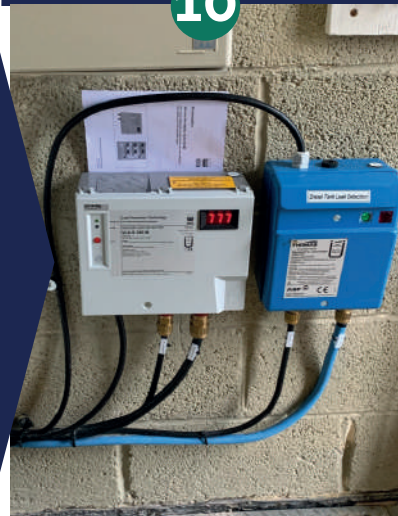
10

Leak detection equipment is installed on site and ran to the vacuum transducer in the tank chamber. All systems are fully operational. Project Complete.
